Historic Structure Report

HISTORIC STRUCTURE REPORT

THE ANTRAM-GRAY HOUSE

Roger Williams National Memorial

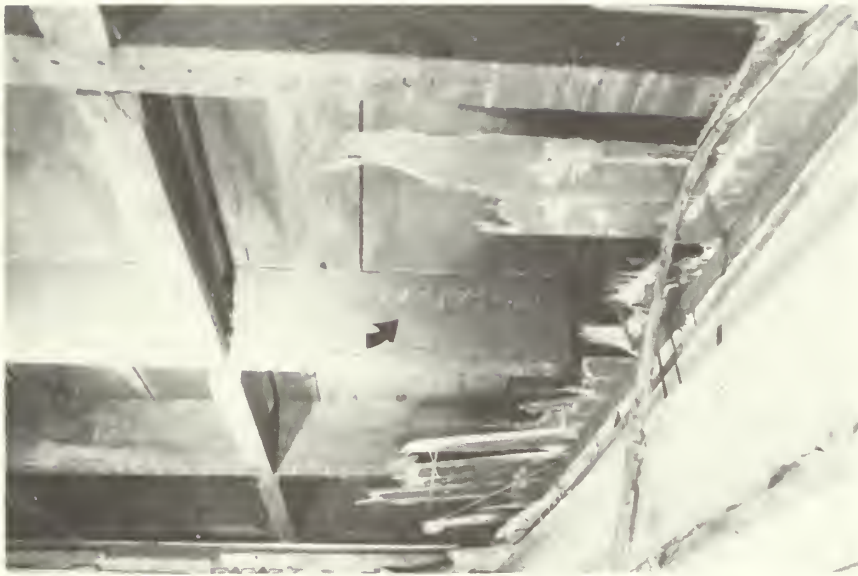
Illustration 14. Antram-Gray House: Second-Floor Joist
Inscribed with Signature and Date.

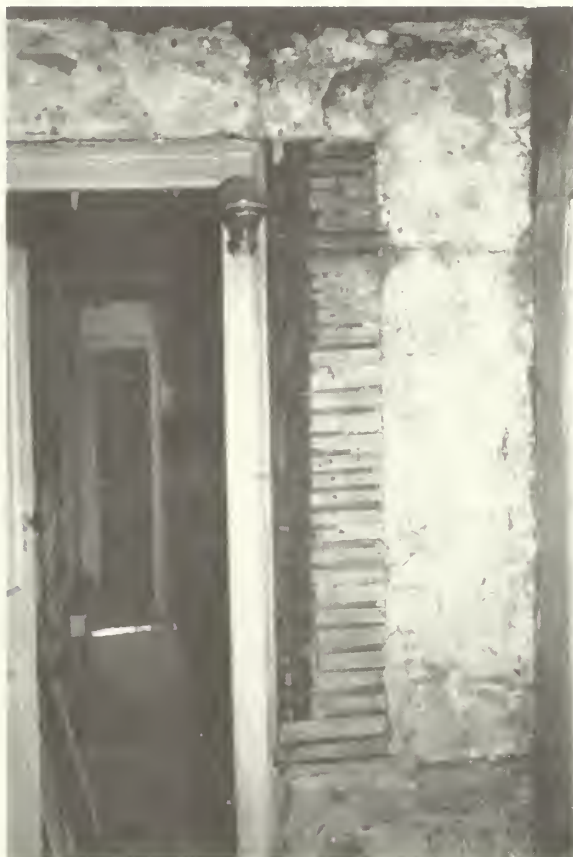
Illustration 17. Antram-Gray House: Plaster Evidence, in South Wall of Room 204, of Circa-1730 Window.

The south facade of the ca.-1730 house was obliterated completely by the ca.-1798 addition. Evidence found in the plaster walls of the second story (Ill. 17) indicates that the windows on this elevation (Ill. 16) were arranged similarly to those of the north elevation. Where the latter had a doorway, however, the south elevation had yet another window.

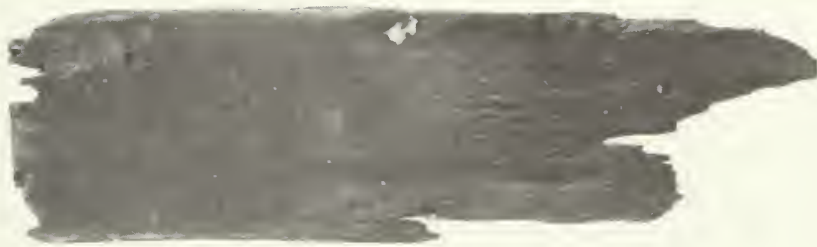
Illustration 18. Wooden Shingle Removed from South Facade of Circa-1730 Antram-Gray House.

The original exterior wall covering was wooden shingles. An original shingle was found in Rcom 202, attached to one of the vertical sheathing boards of the south wall. The shingle measures 3-1/2 inches wide and 13 inches long; it had approximately a 4-1/2 inch exposure (see Illustration 18). It was nailed to the sheathing boards with wrought nails. The shingle is unpainted, indicating that at least the body of the house was unpainted until ca. 1798. Whether or not the wooden trim was painted is unknown.

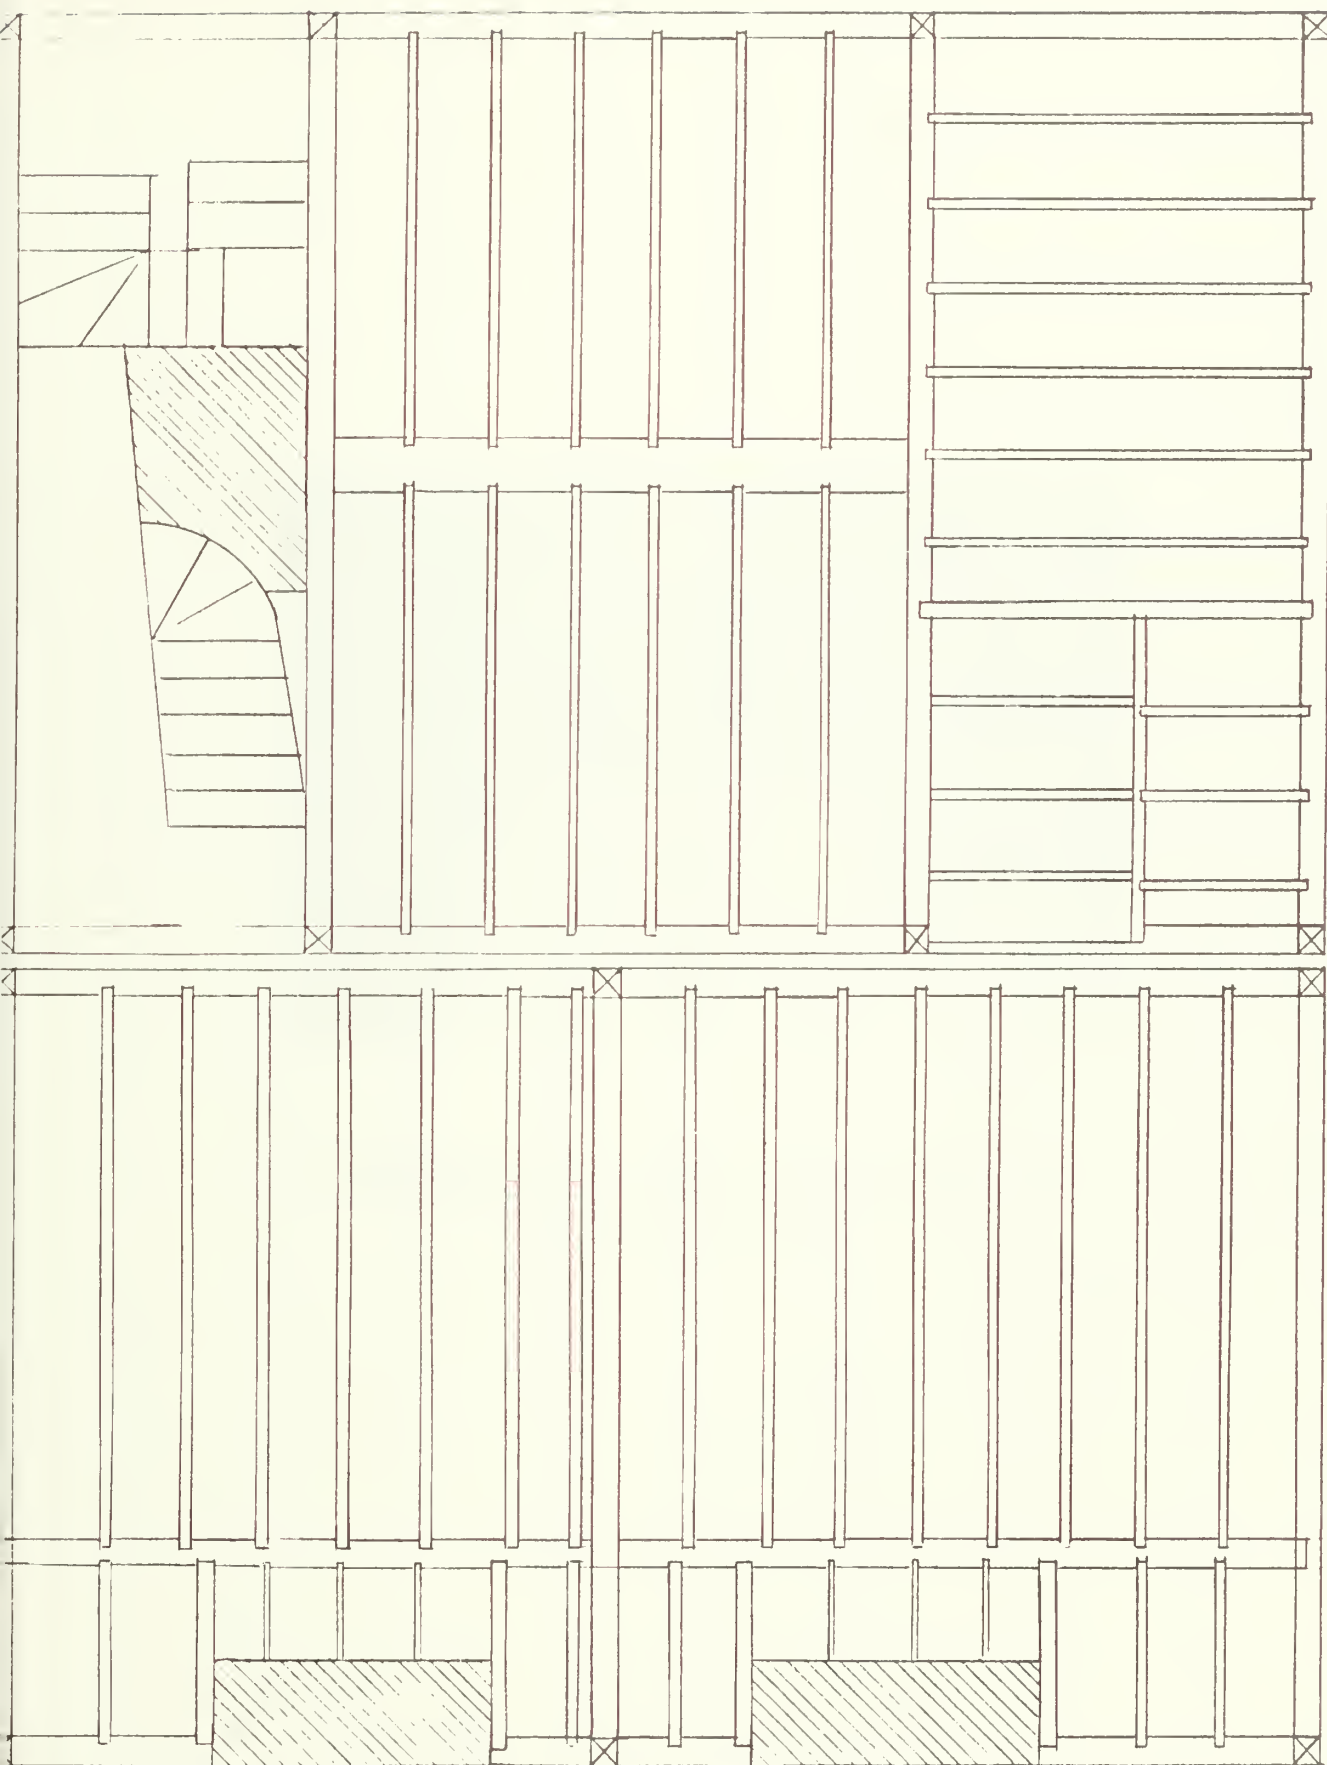
Illustration 21. Antram-Gray House: Second-Floor Framing Plan.

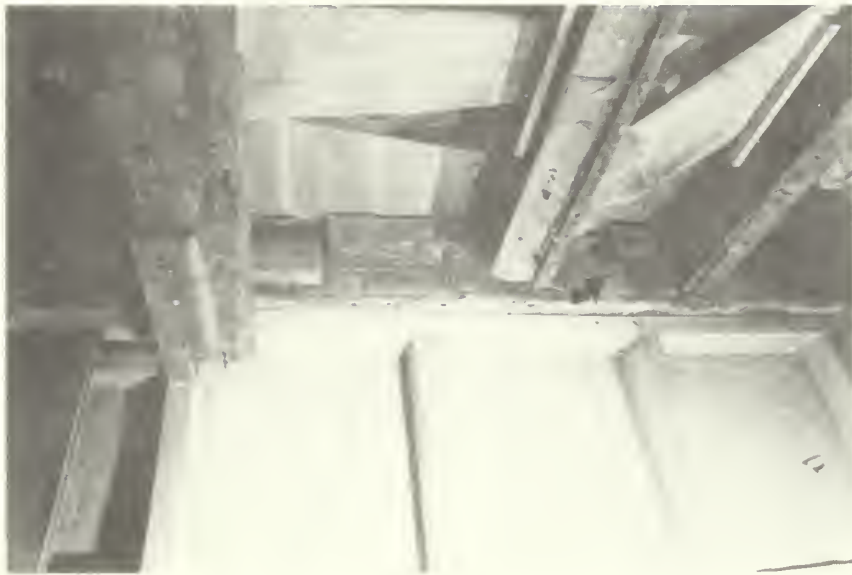
Illustration 22. Antram-Gray House: West Girt of
Circa-1730 House, Showing Former Locations of
Original Floor Joists.

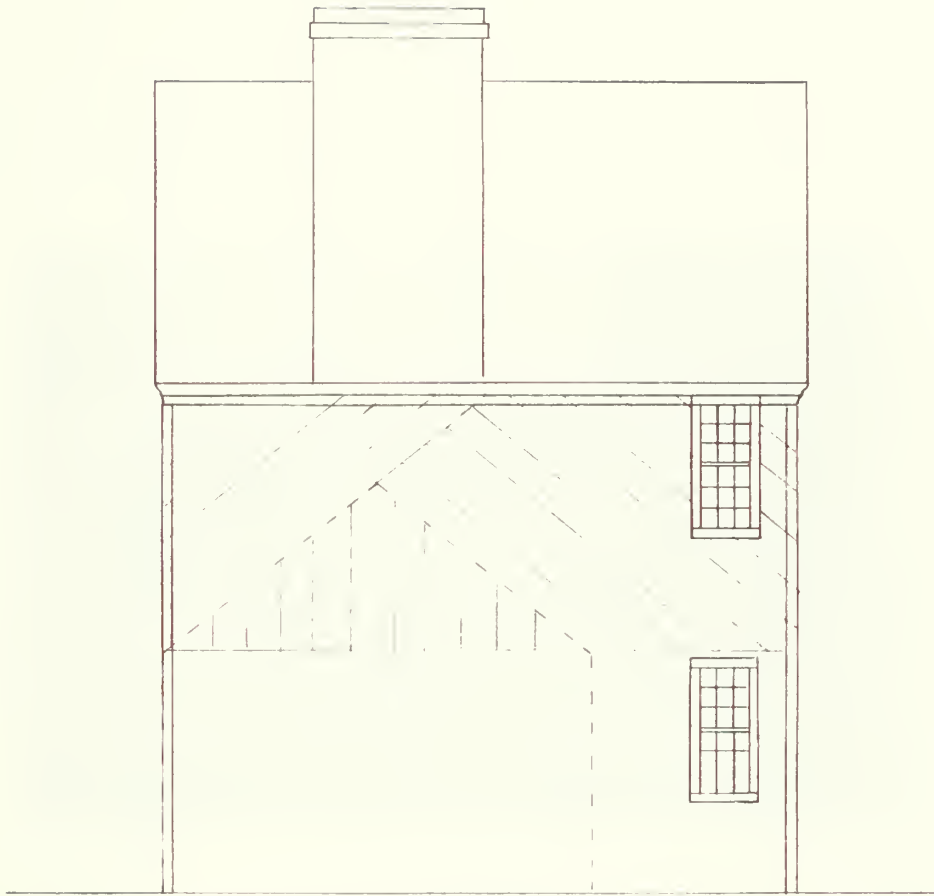
Illustration 27. Antram-Gray House: Sheathing
Evidence, in West Exterior Wall, of
Circa-1730 Ell.

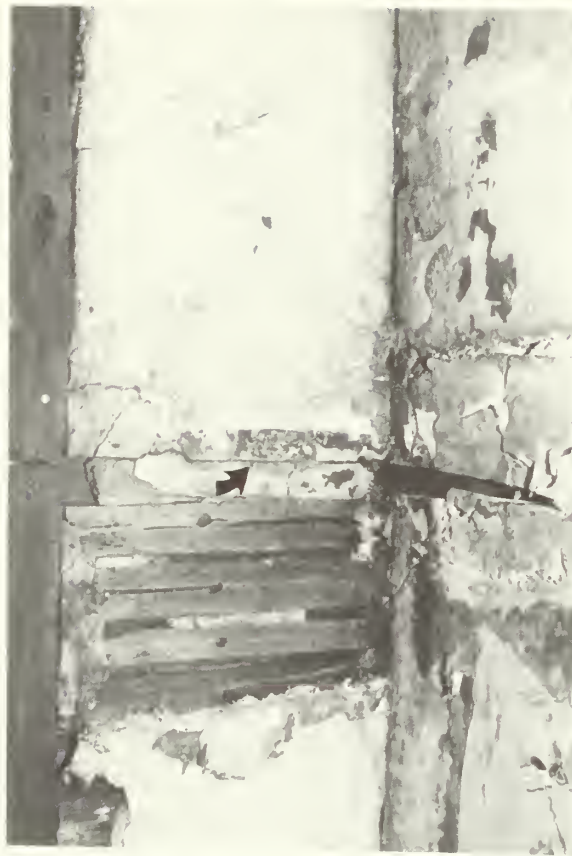
Illustration 30. Antram-Gray House: Painted Border Above Chair Rail, Room 204.

Finally, as stated earlier in "Walls and Ceilings," the original wooden chair rail in Room 204 was removed ca. 1798, judging by the presence of ca.-1798 wallpaper atop the nailer for the chair rail.

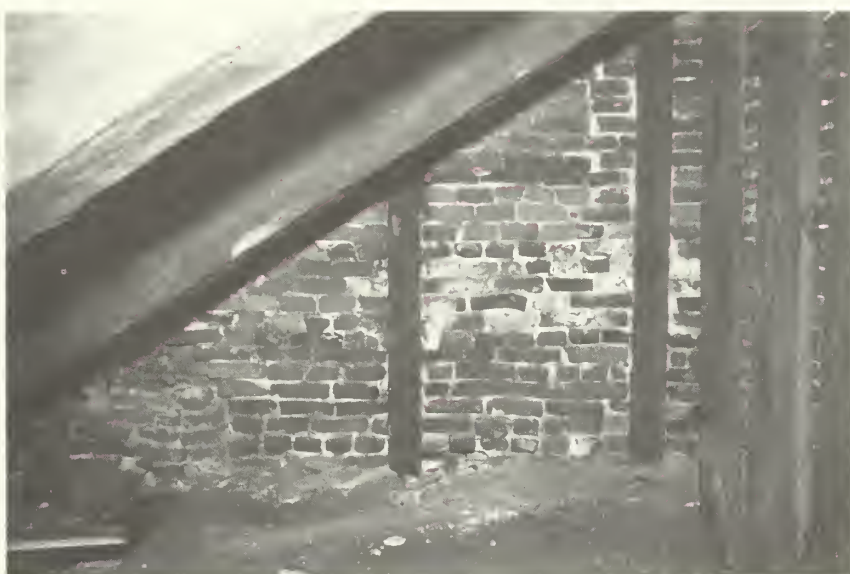
Illustration 37. Antram-Gray House: South Wall of Attic, East End, Showing Studs Embedded in Brickwork.

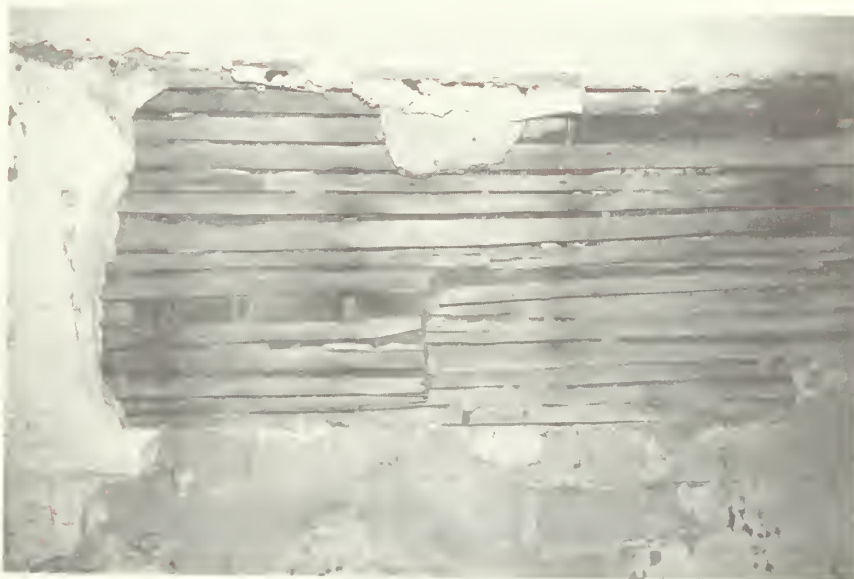
Illustration 40. Antram-Gray House: Type-III Lath and Plaster, Circa 1798, on West Wall of Room 202.

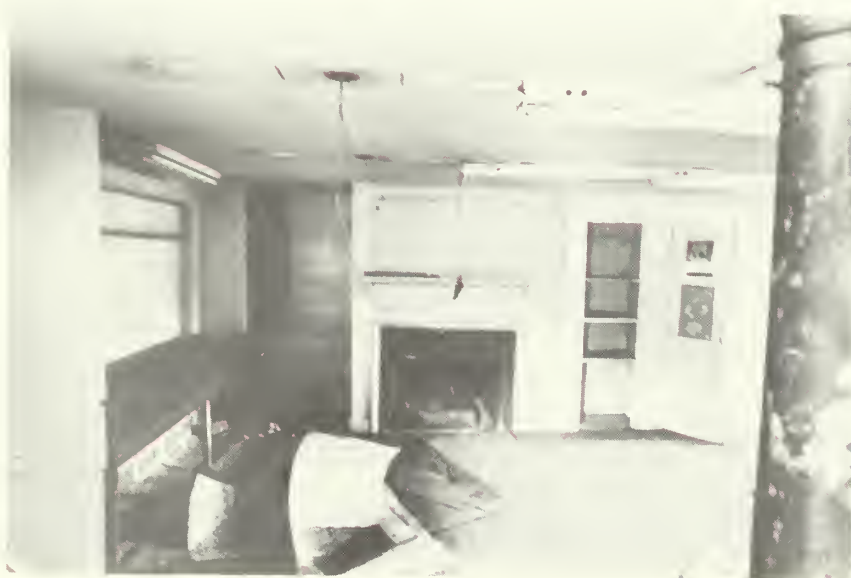
Illustration 41. Antram-Gray House: First-Story Fireplace at East End of South Wall (Formerly in Room 101).

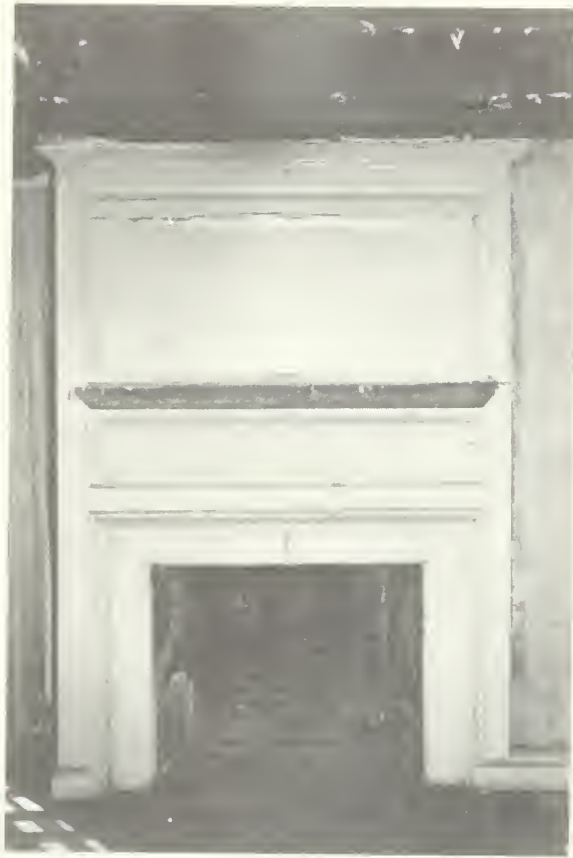
Illustration 42. Antram-Gray House:
Fireplace in Room 201.

The mantel in Room 201 appears to date to the construction of the addition ca. 1798. Most of its components do have as their first paint layer the first layer found on other ca.-1798 woodwork in the room. However, the narrow mantelshelf has an additional layer of dark-red paint beneath its ca.-1798 layer. It thus seems that this mantelshelf was part of one of the ca.-1730 mantels in the original part of the house, and that it was reused here during the ca.-1798 remodeling. It probably came from Room 204 (see "Corner Posts," below).

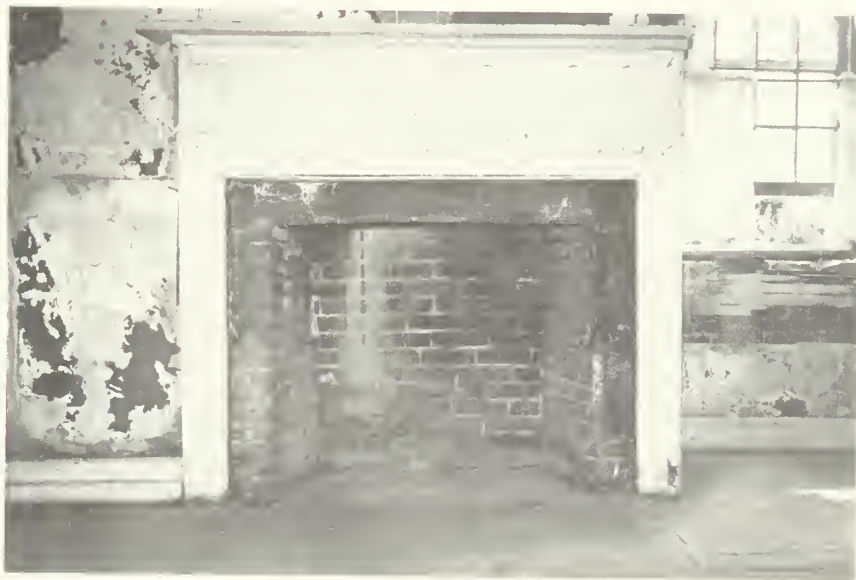
Illustration 43. Antram-Gray House: Fireplace in
Room 202.

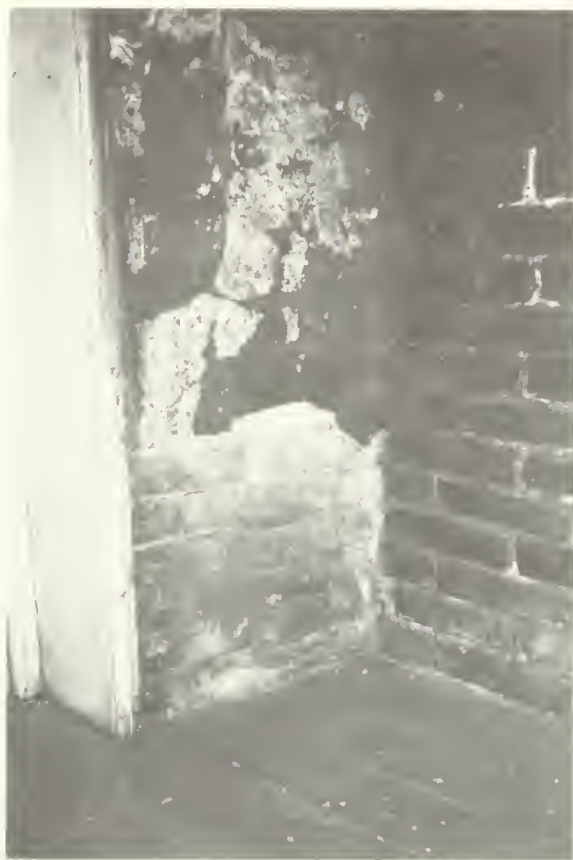
Illustration 44. Antram-Gray House: Fireplace in Room 202, East Side of Firebox, Showing Natural-Cement Targeting.

The firebox opening in Room 202 measures 3 feet, 10 inches wide, 3 feet high, and 1 foot, 3 inches deep. The sides are splayed (Ill. 44). The surfaces of the firebox are covered with natural cement. Embedded in the east side, at heights of 1 foot, 4 inches and 2 feet, 7 inches, are two wrought-iron bolts. The hearth measures 2 feet by 1 foot, 10 inches, and is made of 4-inch square bricks, similar to those used for the fireplace hearth in Room 204. The hearth in Room 204 also has been dated to ca. 1820, as will be discussed shortly.

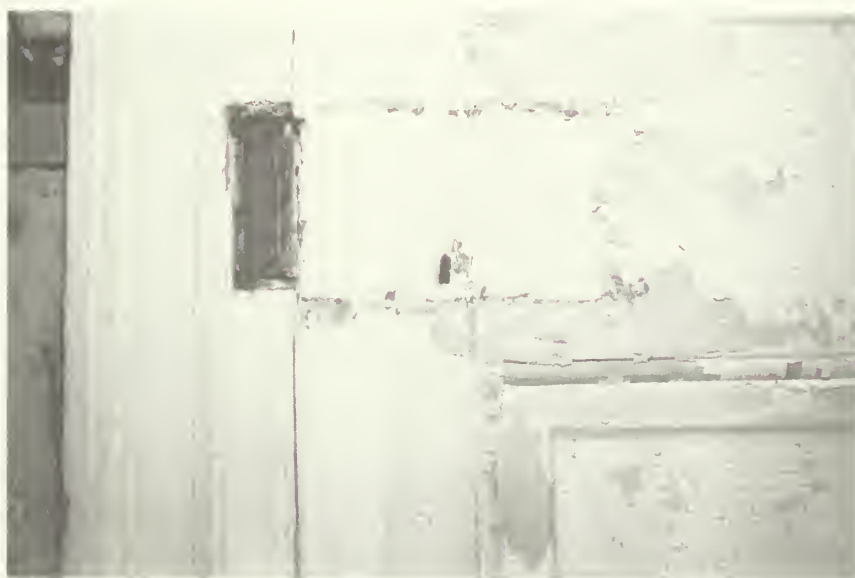
Illustration 45. Antram-Gray House: Door 204, South Side, Showing Paint Evidence of Missing Rim Lock.

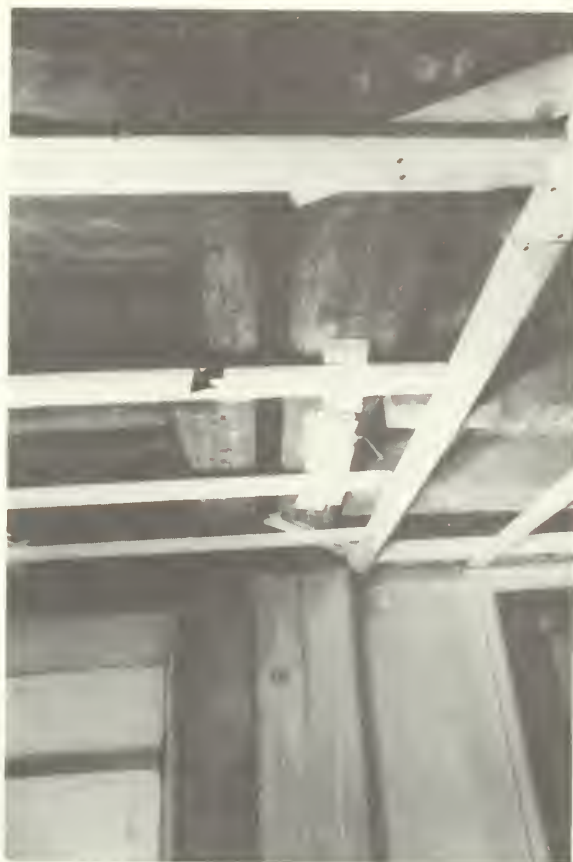
Illustration 48. Antram-Gray House: First-Floor Framing, Showing Circa-1730 South Girt Cut Out for Southeast Stair.

Another ca.-1798 addition to the first-floor story was a stair built in the southeast corner of the original house, in Rooms 105 and 205. This seems to have been required for access to the second-story rooms of the addition, which had no

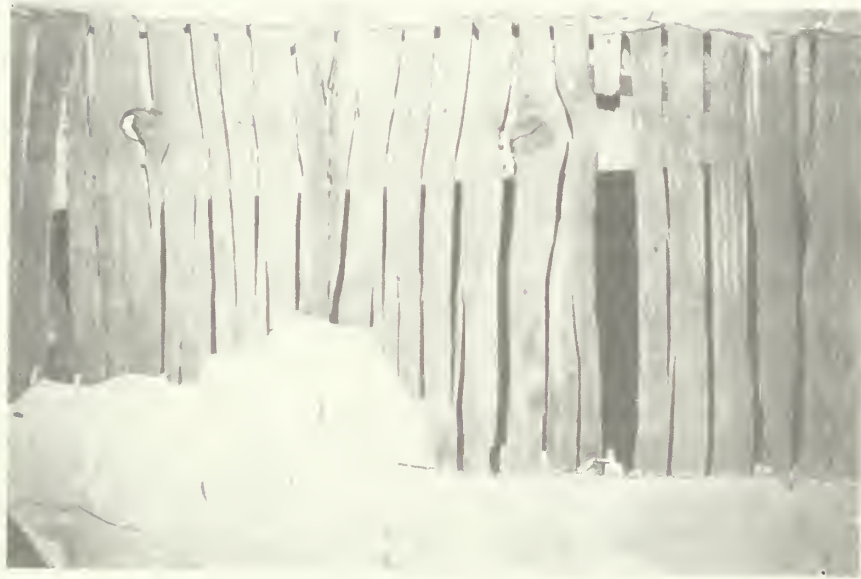
Illustration 50. Antram-Gray House: Accordion Lath and Plaster, Circa 1830, on South Wall of Northeast Attic Room.

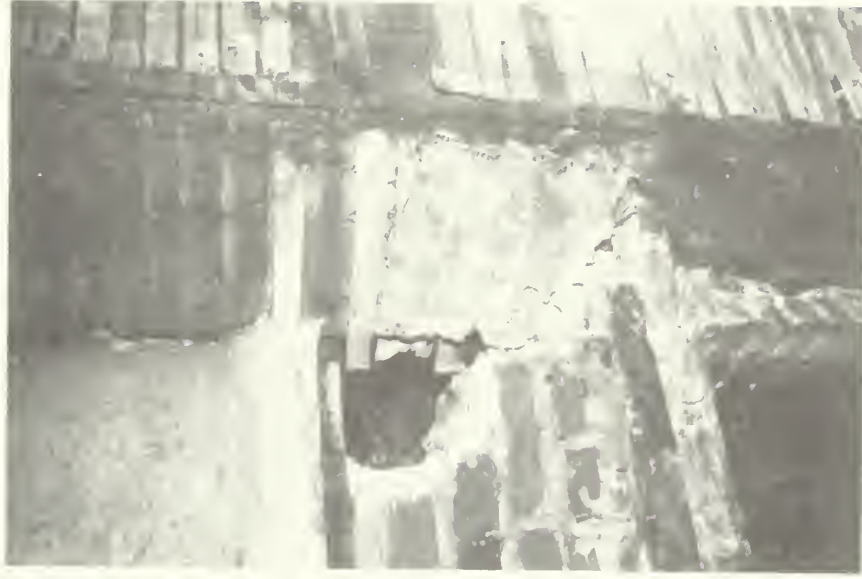
Illustration 51. Antram-Gray House: Plaster and Wallpaper, Circa 1798, Uncovered on North Reveal of Fireplace in Room 204.

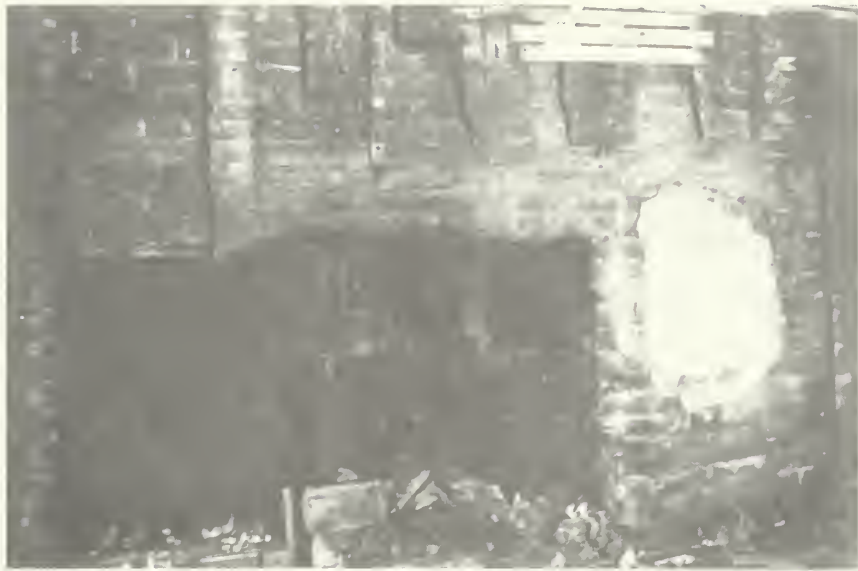
Illustration 52. Antram-Gray House: Uncovered First-Story Fireplace at North End of West Wall (Formerly in Room 204).

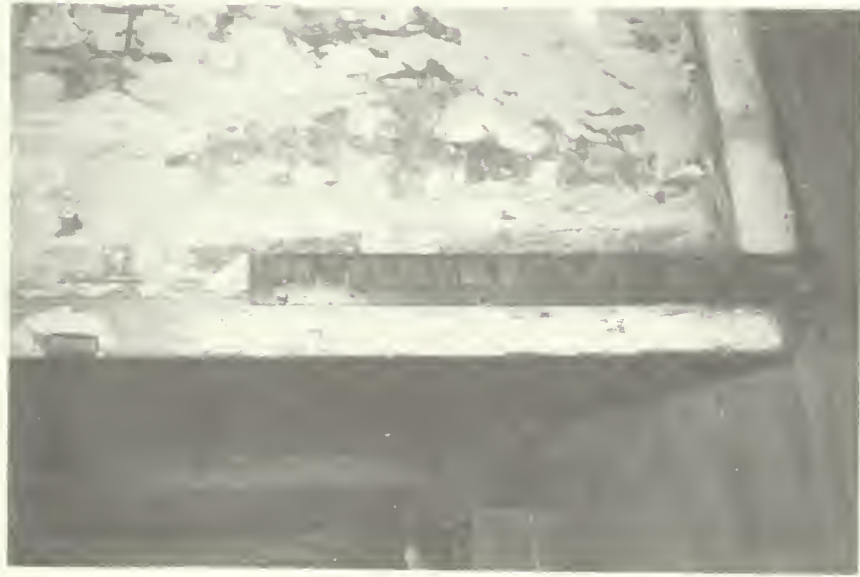
Illustration 54. Antram-Gray House: Fireplace in Room 204, Showing Circa-1820 Overmantel, Mantel, and Firebox.

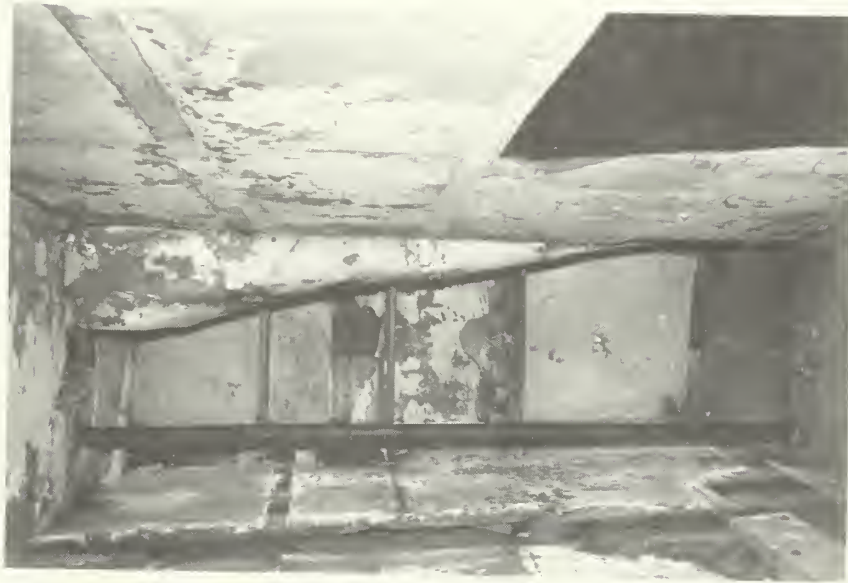
Illustration 58. Antram-Gray House: North End of Room 203, Showing Wooden Shelves.

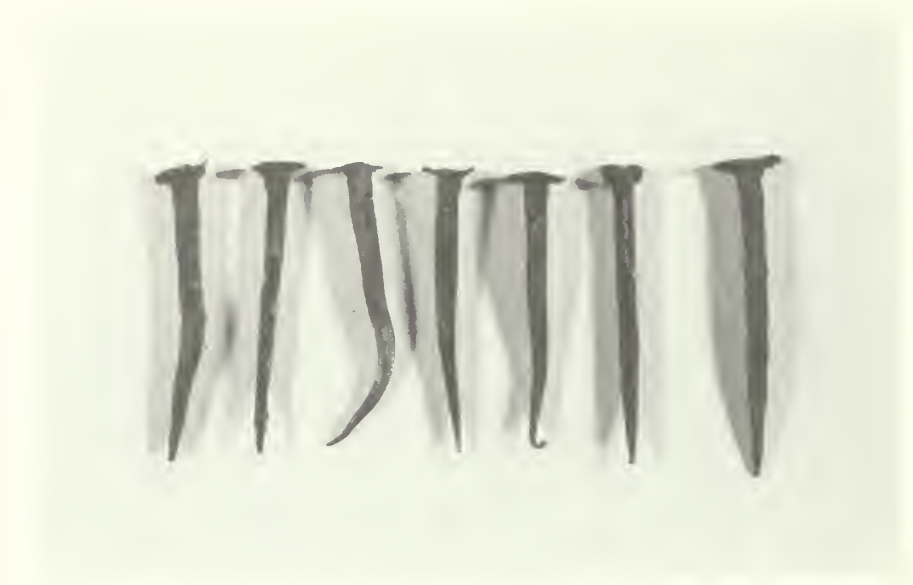
Photograph No. 6: 8d (2-1/2 inch) early machine-cut nails with handmade, T-shaped heads, ca. 1798

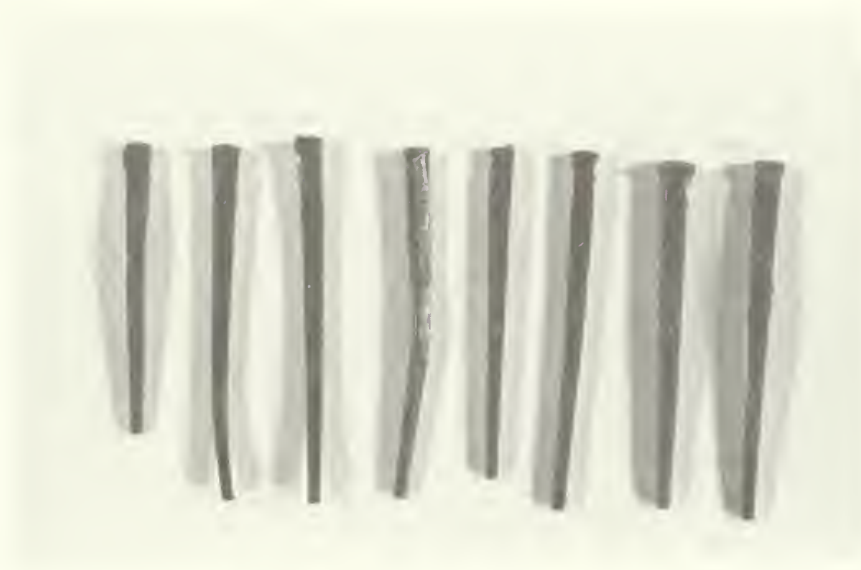
Photograph No. 13: 7d (2-1/4 inch) late machine-cut nails,
ca. 1860
